Effect of maintenance on particulate emissions from residential woodstoves

Literature review and test results from particulate matter measurements based on Norwegian Standard NS3058-59 coupled with EC and OC analyses on an artificially aged woodstove

Commissioned by the Norwegian Environment Agency

VERSION
0.4

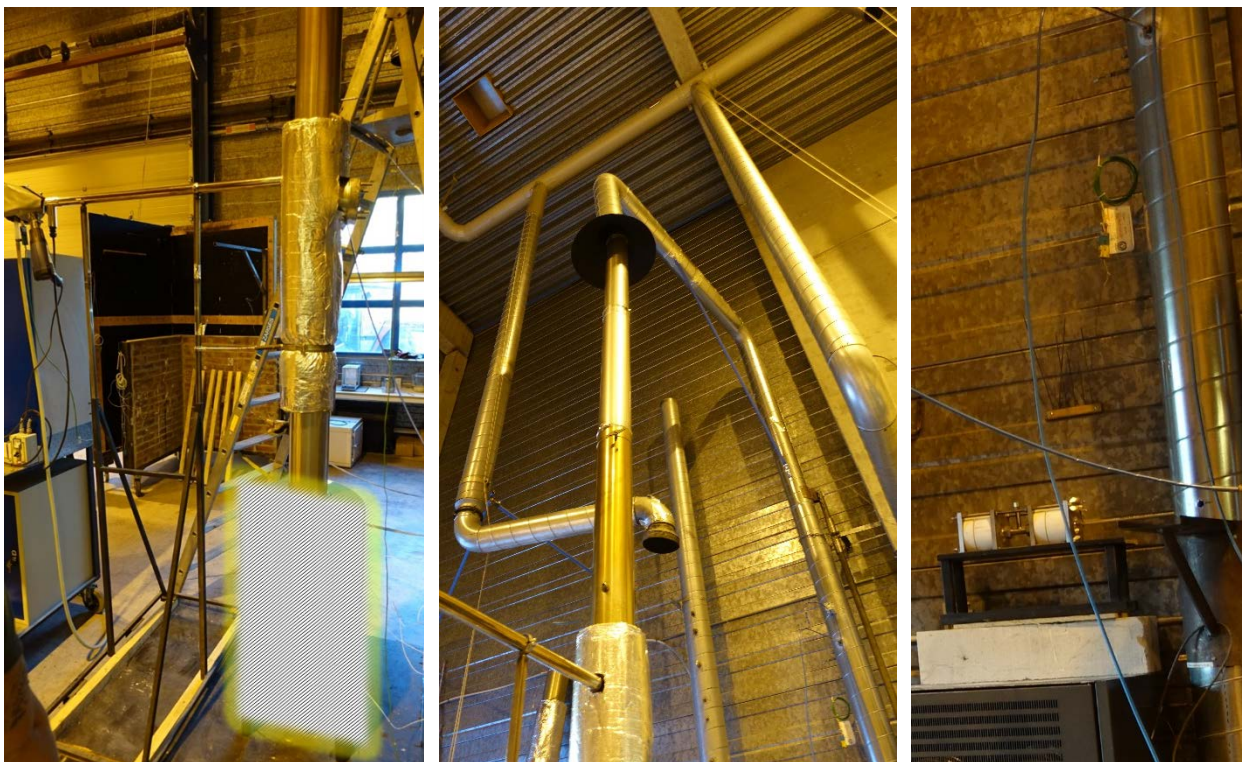
Figure 4: Experimental setup for measurements of particulate emissions with HF above the woodstove (left). The flue gas is diluted further upstream, through the hood (centre), for simultaneous FFDT sampling (right). *Note that the selected woodstove has been intentionally masked, as requested by the manufacturer.*

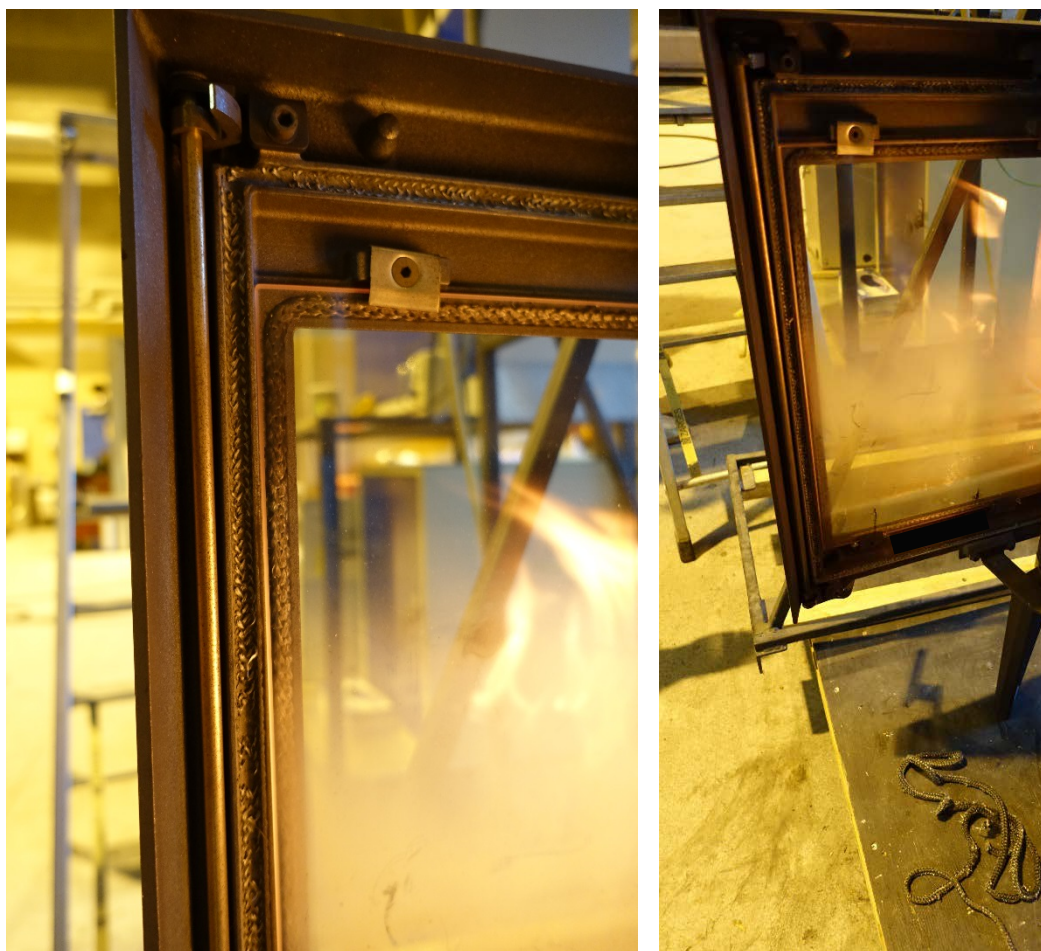
Figure 9: Woodstove door after removal of the gasket.

To best assess experimentally the effect of aging of the woodstove, it had to be modified punctually so that measurements could be performed before and after modification. From discussions with research partners and observations from the literature, it was concluded that creating a significant artificial air leak through the door was the best solution to simulate aging of the woodstove. The modification was performed by simply removing the sealing gasket originally set all around the door of the woodstove (see Figure 9). The subsequent presence of non-preheated air at undesired locations is expected to affect dramatically the combustion conditions and eventually the resulting particulate emissions. Though this measure represents a rather extreme case, it will illustrate a worst case scenario regarding air leakage into a woodstove.

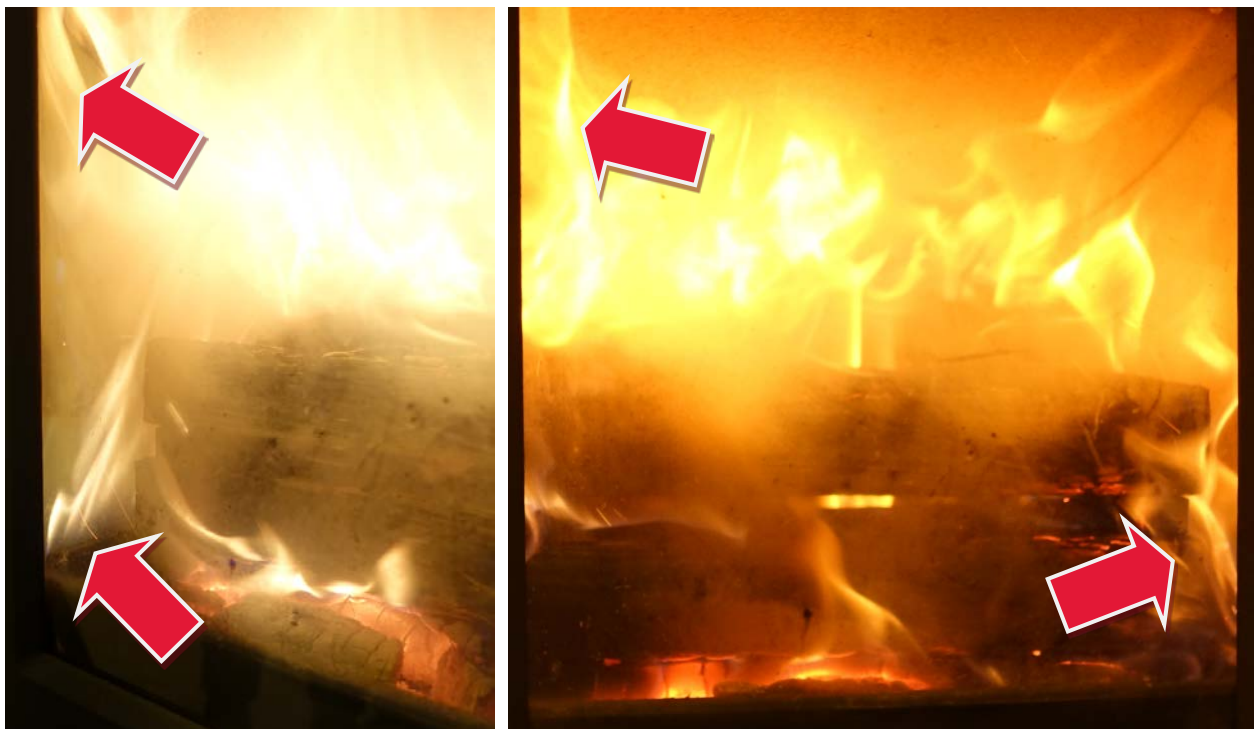
Figure 10: Pictures of test fuel burning in the woodstove burning after removal of door gasket.

As a first observation during the tests, after removal of the door gasket, the flames inside the woodstoves, usually located above the firewood, were also seen anchored nearby by the contour of the door, highlighting the air leaks artificially created. Such anchored flames are indicated by red arrows in Figure 10. As the excess air penetrating the combustion chamber was not controlled, the flames were particularly intense, yielding a relatively high burnrate for a 3-mm opening of the air regulator, which usually yields a low burn rate (3.16 kg dry wood /h versus 1.19 kg dry wood /h). This phenomenon results in producing a larger amount of heat than expected (10 kW versus 5.4 kW), though, over a shorter time period.

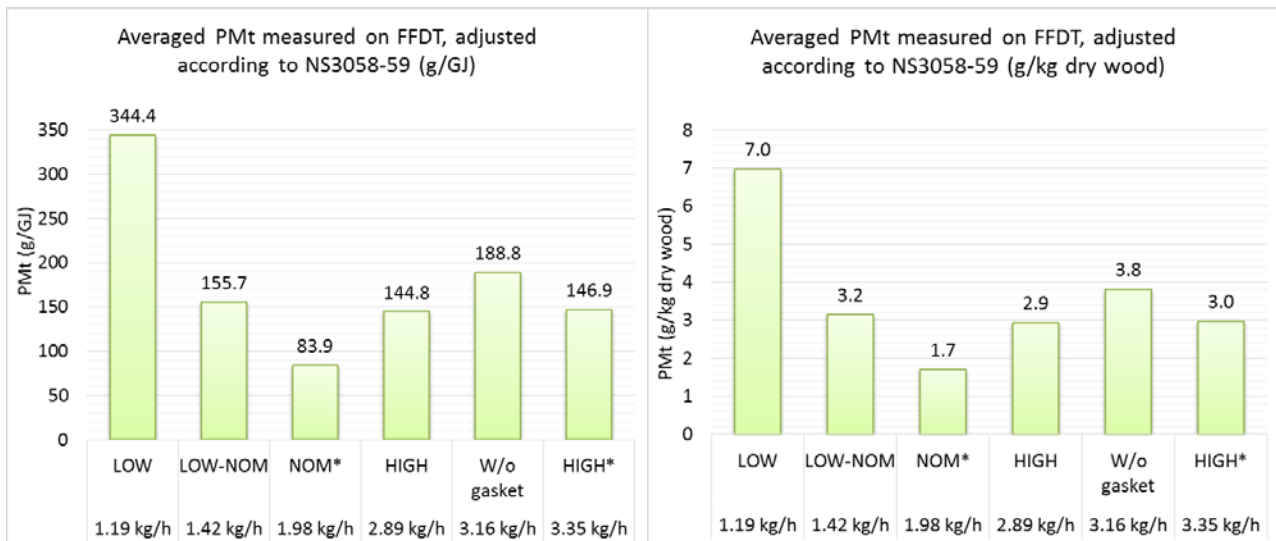
Figure 12: TSP measured on FFDT filters, using spruce as test fuel. The results are sorted from low to high burnrates with the amount of wood combusted per hour indicated for the different burnrates. Left: results in [g/GJ]; Right: results in [g/kg dry wood]. The tests marked with a star stem from previous tests on the same stove [4].

The average TSP measurements are shown in Figure 12 for the (FFDT) filters 4 averaged sets of data from the present results ("LOW", "LOW-NOM", "HIGH" and "W/o gasket") and 2 from [4] ("NOM*" and "HIGH*"). Previous results from nominal conditions ("NOM*") are shown here since they correspond to the best achievable (lowest) TSP emission factors. Previous results at high burnrate ("HIGH*") are shown here since their averaged burnrate is similar, though slightly above the one of the tests without gasket ("W/o gasket").

- At low burnrate ("LOW"), the FFDT filters have captured a much higher TSP level (344.4 g/GJ, equivalent to 7.0 g TSP/kg dry wood) than for any other tested burnrate. In nominal conditions ("NOM*"), the TSP emission factor is 83.9 g/GJ (equivalent to 1.7 g TSP/kg dry wood), the lowest of all, and lower than the certification result of 2.1 g TSP/kg.
- After door gasket removal, the measured TSP emission factor reaches 188.8 g/GJ (corresponds to 3.8 g TSP/kg dry wood). Though this result is about half the emission factor of the low burning rate (cf. "LOW" versus "W/o gasket" in Figure 12), it is about 29 % higher than the emissions of a corresponding burning rate ("HIGH" and "HIGH*"), and about two times the emissions that the stove was certificated for.

This shows that, despite the degradation of the combustion conditions, the presence of a large air leakage does not necessarily lead to more TSP than at equivalent opening of the air regulator (3 mm in "LOW" and "W/o gasket") without leakage. This is due to the extra air entering the combustion processes, which disrupt the fuel-rich conditions of the low burnrate and lower the total output of TSP, though the composition of the resulting TSP might differ.

However, TSP levels from FFDT filters after door gasket removal are found more than twice higher than for the nominal case ("NOM*"), and 28-30% higher than for an equivalent burnrate ("HIGH" and "HIGH*"). This shows that despite the extra air incoming into the combustion chamber due to the leakage, the combustion processes mastered in the nominal case would be altered by a strong air leakage up to yielding much higher TSP levels. Compared to equivalent high burnrate conditions, the extra air entering the combustion chamber through the leakage is colder than in regular conditions, which appear to affect the combustion processes by increasing the resulting TSP emissions factor.

It should also be noticed that all emission factor measurements are far below NS3058-59's weighted TSP emission factor limit of 10 g/kg dry wood (see Figure 12), even the averaged measurement after door gasket removal and the low burnrate case.

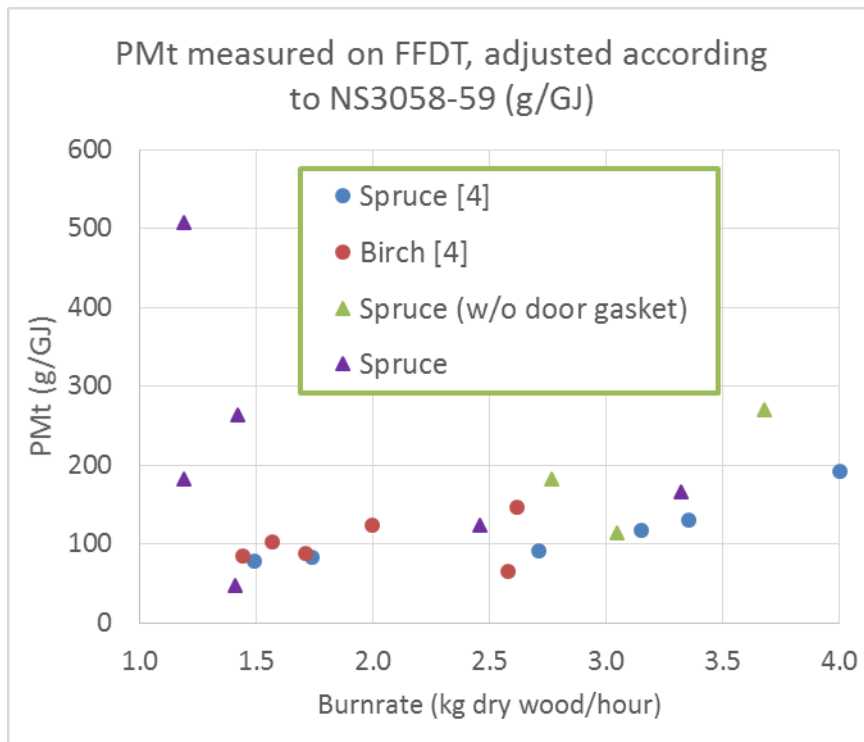
Figure 13: TSP measured on FFDT filters with a large group of tests performed prior to removing the door gasket, and after removing the door gasket (in green). All tests were performed under NS3058-59 conditions. The measurements detailed in this report are marked as triangles.

Individual TSP emissions factors are shown against the burnrate in Figure 13 and Figure 14 for the tests #26 to #32, along with previous comparable results from the current project⁴. This is to give a wider perspective of the results regarding the actual burnrate achieved during the tests. Two of the three TSP emissions factors from the FFDT filters shown in Figure 13 for the tests after door gasket removal appear higher than previous tests for similar high burnrates with spruce namely test 30 and 31. The third emission factor (around 3.05 kg dry wood/hour) from test 32 appears in the same range as previous tests.

Comparing Figure 13 and Figure 14, there is a striking difference at low burnrate, where FFDT filters seem to capture much more TSP than the HF. The differences between the two types of measurements can be explained by the condensable gases flowing through the HF without being captured, while mostly condensing on FFDT filters at lower temperatures. The HF is kept above 70 °C to avoid adsorbing condensable gases. However, the FFDT filters are operated through the dilution tunnel under 35 °C and would allow adsorption of part of the condensable gases and/or eventually capture condensed vapours onto existing particles or particles formed by nucleation of condensable gases.

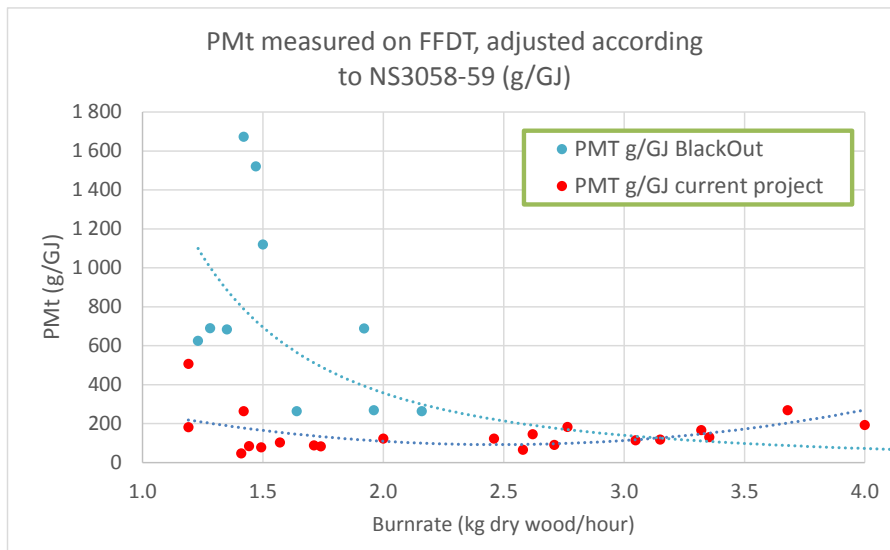
Figure 15: Comparison of PMt emissions in g/GJ, previous project BlackOut vs current project. The stove used in BlackOut was a Jøtul F3 with modern technology. In the current project, measurements were performed at a stove with even better technology and more optimized towards low emissions at low loads.

The current results for TSP was compared with the Jøtul F3 stove tested in the previous BlackOut project. As can be seen in Figure 15, the current stove is more optimized for low burn rates in terms of particle emissions.

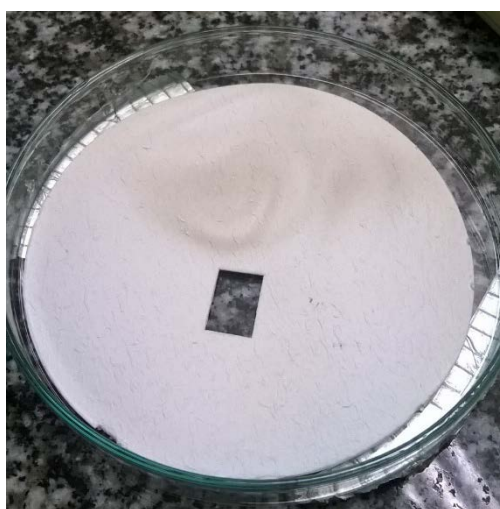
Figure 17: Example of sample for EC/OC analysis taken from one quartz filter with a trace of leakage.
